# **Survey and characterization of historical mortars of the church of San Pedro Apóstol in Polvoranca (Leganés, Madrid): constructive aspects and petrological analysis**

*SUMMARY: This research studies the mineral composition characterization and internal texture of selected mortars collected from the church of San Pedro Apóstol of Polvoranca (Leganés, Madrid). The aim of the survey is to provide as much additional information as possible through the archaeological investigation so as to achieve a better understanding of the remains and to establish the chronology of the archaeological group.*

**Historical Mortars Conference**

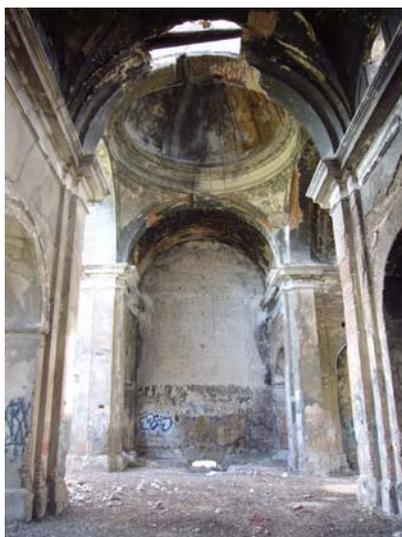
The conservation of the cladding is relatively good in some of the wall panes, whereas in some other parts it has spalled, and some are covered with graffiti paintings.

Figure 4. State of the interior mortar rendering

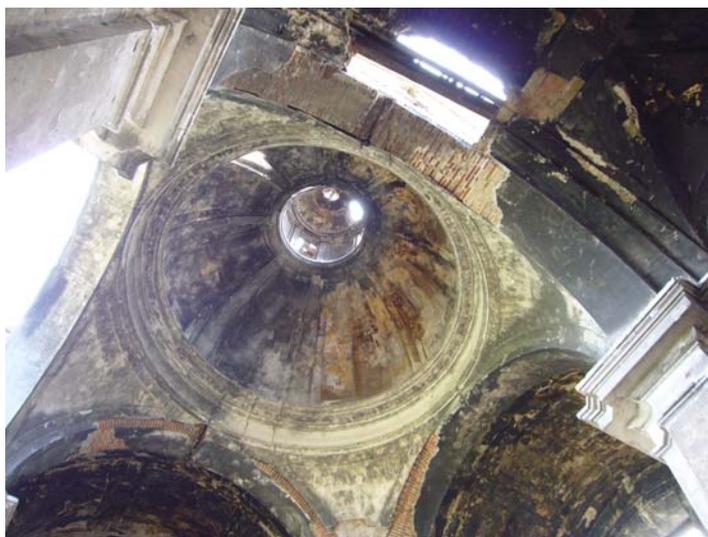
The interior of the church, very deteriorated, includes gypsum plastering decorated with mouldings. The church dome, which has collapsed, showed an intermediate solution regarding the Madrilean typology: from the exterior, the dome was covered by a cubic body crowned by a helm roof lantern.

Figure 5. State of the church dome interior mortar rendering

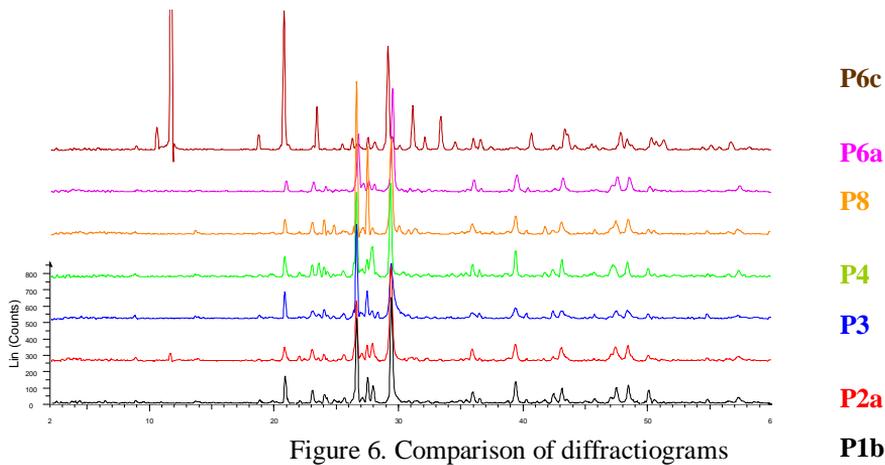
Figure 6. Comparison of diffractograms

As can be seen, all the samples, except for P6C, correspond to mixtures of calcite, feldspar and quartz.

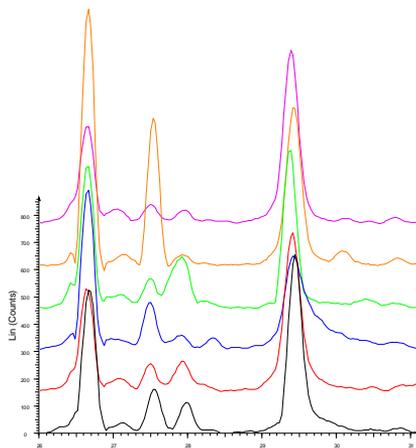
Figure 7. Detail of the area of main peaks of the diffractograms. A comparative study.

If the maximum diffraction of the samples is analyzed, these can be classified into two main groups:

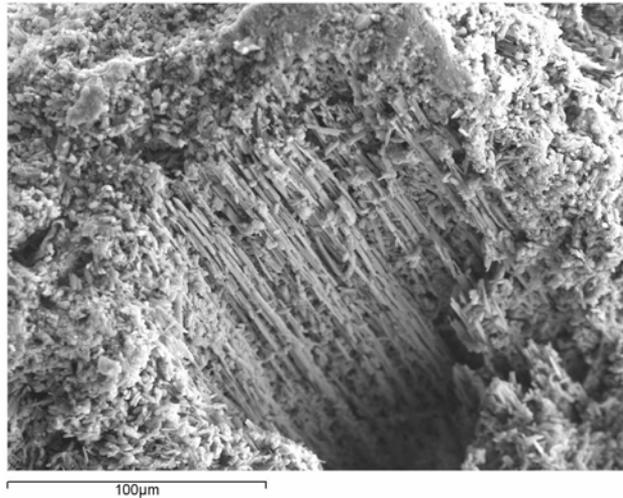
Figure 8. Electronic Microscopy ScannerPhotograpgh of sample p6C. There are gypsum crystals covering a hole of a possible earlier anhydrite. The sample corresponds to the joint mortar of the church.

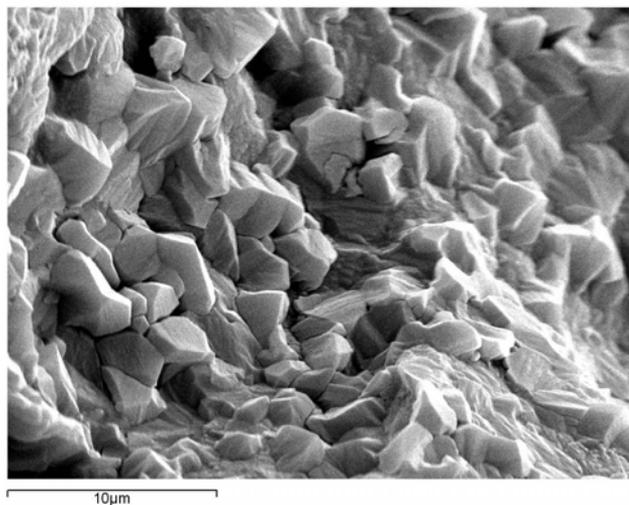
- Group 1: Samples P1b, P2a, P4 and P6a. In this group, calcite is more abundant than quartz. In addition, in the P2 sample there are traces of gypsum.

Figure 9. Sample of calcite crystals corresponding to the foundation joint mortar of the church. The sample belongs to Group 1 of the analysis.

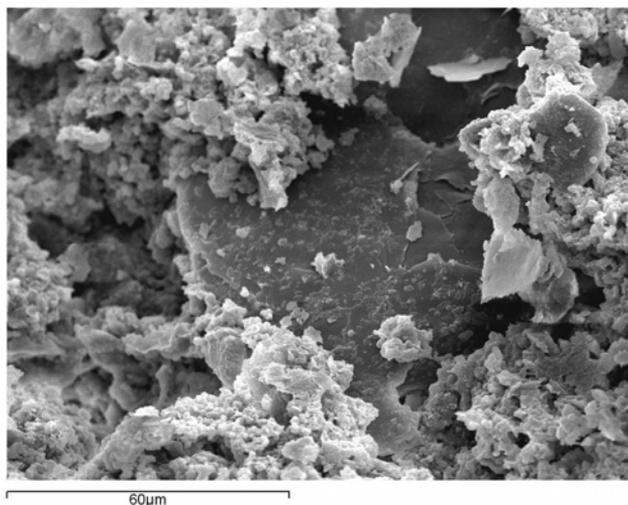
- Group 2: Samples P3 and P8. In this group, quartz appears in greater quantity than calcite, although there are differences between the two samples since in the P8 sample there is more potassic feldspar than in P3.

Figure 10. Joint mortar representative of the tower structure located South-east of the building group. This mortar corresponds to Group 2 of the analysis.
