MEGARA Optics: stain removal in PBM2Y prisms

2017 J. Phys.: Conf. Ser. 792 012064

Abstract. MEGARA is the new integral-field and multi-object optical spectrograph for the GTC. For medium and high resolution, the dispersive elements are volume phase holographic gratings, sandwiched between two flat windows and two prisms of high optical precision. The prisms are made of Ohara PBM2Y optical glass. After the prisms polishing process, some stains appeared on the surfaces. For this, in this work is shown the comparative study of five different products (muriatic acid, paint remover, sodium hydroxide, aqua regia and rare earth liquid polish) used for trying to eliminate the stains of the HR MEGARA prisms. It was found that by polishing with the hands the affected area, and using a towel like a kind of pad, and polish during five minutes using rare earth, the stains disappear completely affecting only a 5% the *rms* of the surface quality. Not so the use of the other products that did not show any apparent result.

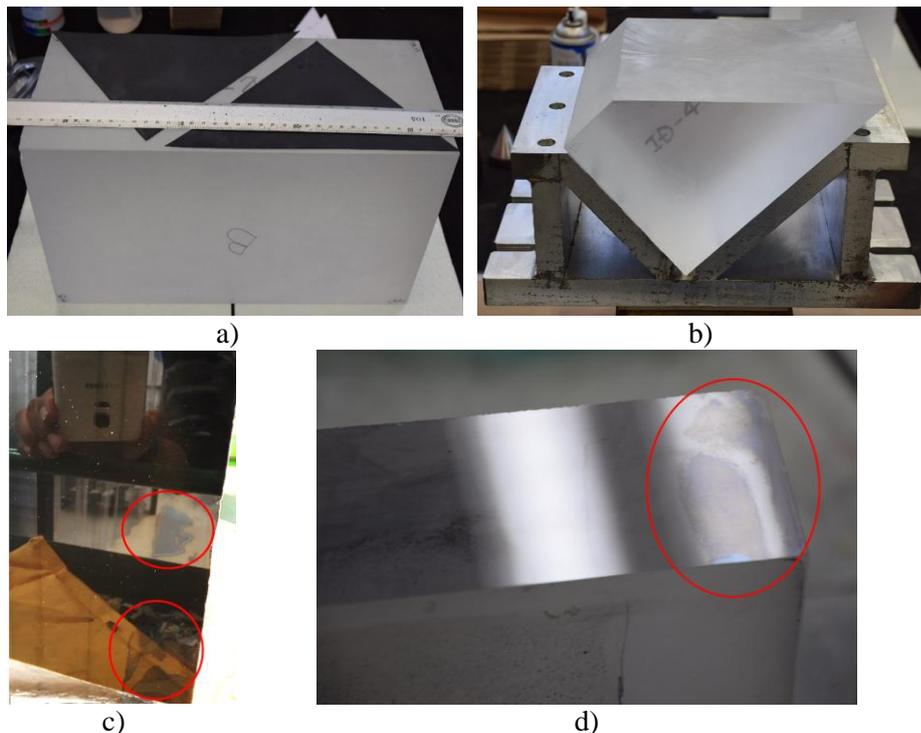
In figure 1b, are shown the prisms mounting used during the polishing process. In the instrument design, the prisms have two polished surfaces. The required quality of the prisms HR are, for the first surface, 1 frg at the used aperture (180mm x 140 mm); and 0.5 frg at the central aperture (160 mm x 150 mm). For the second surface, the required quality is 2 frg at the used aperture (180 mm x 200 mm); and 1 frg at the central aperture (160mm x 200 mm). The first surface was designed to have an antireflective (AR) coating while the second surface will be cemented with a fused silica window.

Figure 1. a) Ohara PBM2Y blank, b) HR prism mounted in a cast iron base, c) and d) stains on the polished surface.

During the polishing process, the prism is mounted in a cast iron base made in a CNC machine [7]. To clamp the prism in the base blocking wax was used. When the second surface of the prism is polished, the first surface is covered with a protecting coating to prevent scratches or digs. Then the prism is stuck to the base with wax. The stains problem appeared on the first surface when the polishing of the second surface was ended and the prism was removed from the mounting and it was cleaned [7], see figure 1c. It is believed that the stains were produced by the combination of the wax, the protected coating and the high temperature used to melt the blocking wax ($\approx 70^{\circ}\text{C}$). In figure 1d the stains are evident on the surface by using the reflection of a fluorescent lamp; we can compare the left side of the surface that it is free of stains. It is important to say that these stains appears only on a polished surface and are present in an optical glass with high acid resistance value.

These kind of stains on MEGARA prisms could produce diffused images, optical quality decreasing and maybe some problems with the AR coating or in the cementing with fused silica windows [1]. Thus, it is important that this optics do not have any kind of stains to avoid damages and guarantee the instrument performance.

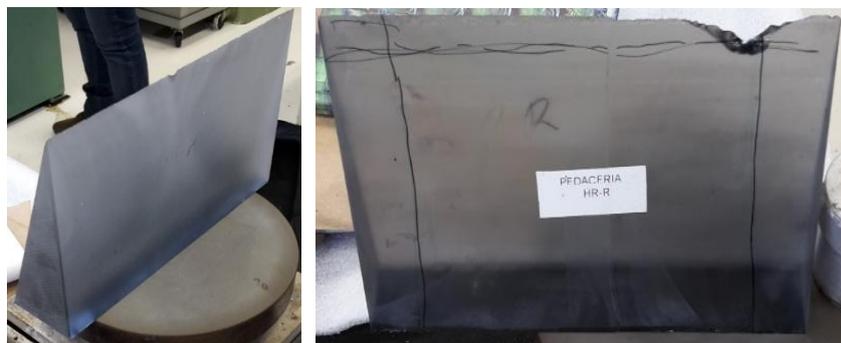
pieces of glass have the same stains problem as the principal prism on the polished surface (large basis of the prism, figure 2).

Figure 2. PBM2Y polished piece used for the cleaning tests.

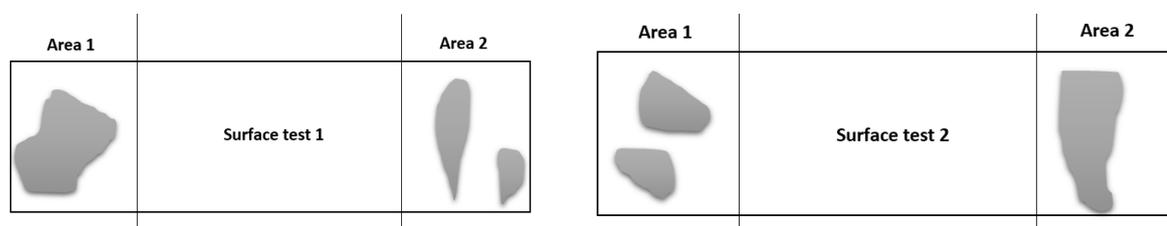
The piece of glass was divided into three parts and the cleaning test was made on the ends of each surface. Figure 3 shows how the glass was divided.

Figure 3. Scheme of the pieces used for the cleaning tests.

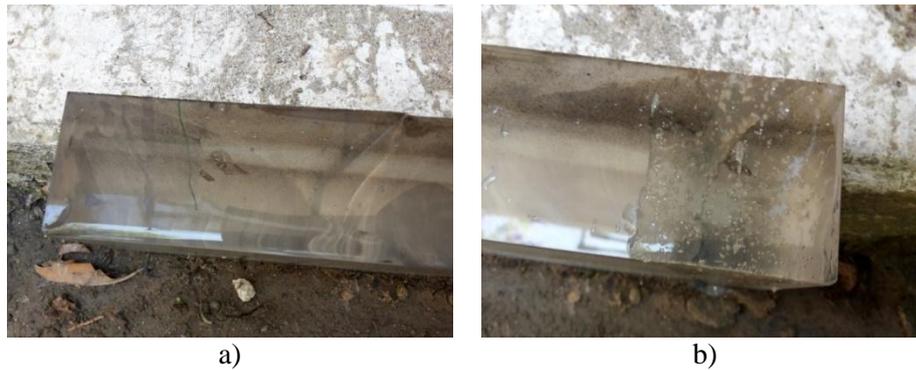
The first product was spread it above the stains of the surface test 1, area 1 figure 4a; the second product was spread it above the test surface 2, area 1 figure 4b. Both products were left act during 20 minutes but the results obtained were negatives and none of the products produced any perceptible change removing the stains.

Figure 4. Tests with a) hydrochloric acid, and b) paint remover.

The first tests were made with two different commercial products. The first product was Hydrochloric acid (muriatic acid), and the second product was paint remover (water + benzyl alcohol +titanium dioxide). These kinds of products were used because it was thought that the stains could be produced by a kind of thin film deposited on the surface because the chemical evaporation produced by the protecting coating and the blocking wax. Also these products are easy to get in any hardware store.

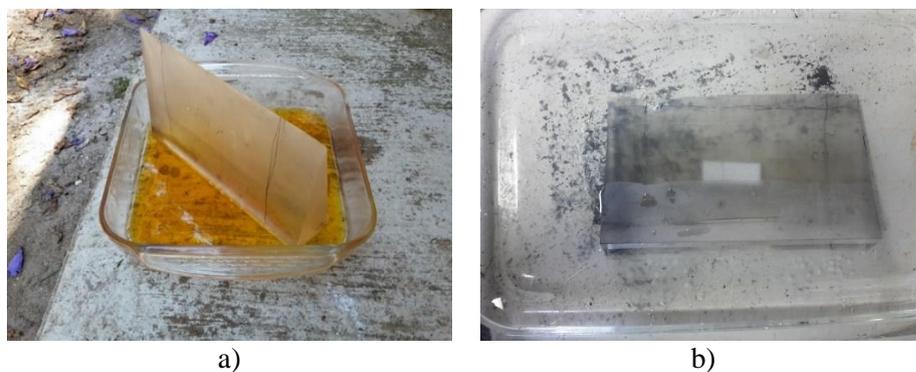
The two products were left act during 4 hours and the areas under test were checked every 20 minutes to see the progress. During that time was observed that the sodium hydroxide did not cause any apparent change on the surface stains. Whereas that, a little change or vanishing on the surface stains after two hours was observed with the aqua regia, but the stain did not disappear completely.

Figure 5. Tests glasses into a) aqua regia and b) sodium hydroxide.

The first surface test was left soaking in aqua regia, figure 5a, and the second test surface was left soaking in sodium hydroxide, figure 5b. This procedure was done similar to the process that is followed when a thin film of aluminum coating is removed from optical mirrors.

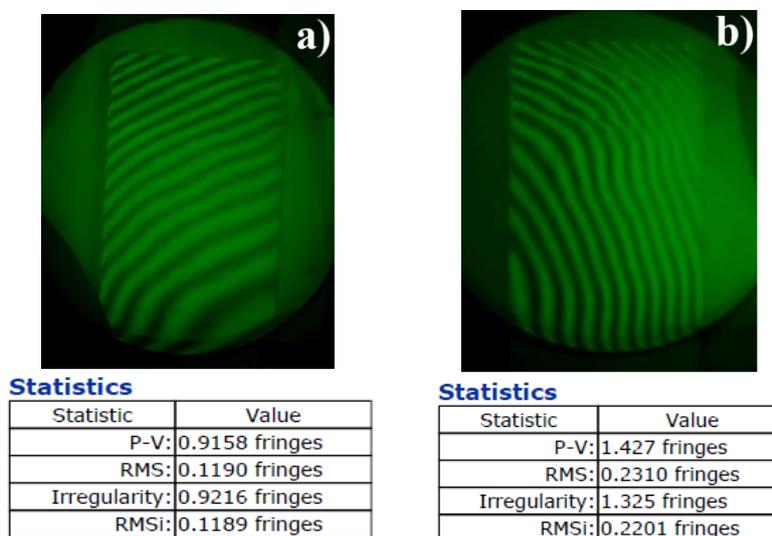
Before polishing the area 2 of the first surface, the interferogram of figure 6a was captured. The values obtained when this interferogram was analyzed were 0.9158 frg PV and 0.1190 frg *rms*. The polishing process was done as follow: the area of interest was polished following a path of circles and using a smooth cotton towel similar to a polishing pad, this was done until the stains disappeared completely. This process took about 5 minutes.

Figure 6. Data and interferogram a) before and b) after polishing surface 1.

Figure 6b shows the surface interferogram after hand polishing. As can be seen, the values of PV and rms were 1.427 frg and 0.2310 frg, respectively. It is observed that two values increased more or less 55% and 94%, respectively. This can be corroborated by observing the interferograms of figure 6b where the fringes are irregular compared with the interferogram fringes of figure 6a.

Although the stains almost disappeared, the problem of scratch and digs appeared on the surface. This effect is attributed to the aqua regia which caused damage to the surface due to its highly corrosive nature.

In order to follow the figure behavior of the surface during the hand polishing we did an interferometric analysis of the surface irregularity. This analysis was done by using a Newton interferometer with a wavelength of 546.1 nm and an Edmund Optics lambda/10 reference flat. An interferogram was taken before and after the hand polishing. The interferogram was analyzed with the Durango interferometry software (Diffraction International Inc.). With this analysis, we can know the influence of the hand polishing on the surface irregularity in terms of PV and *rms* values. The results obtained in these tests are shown next.

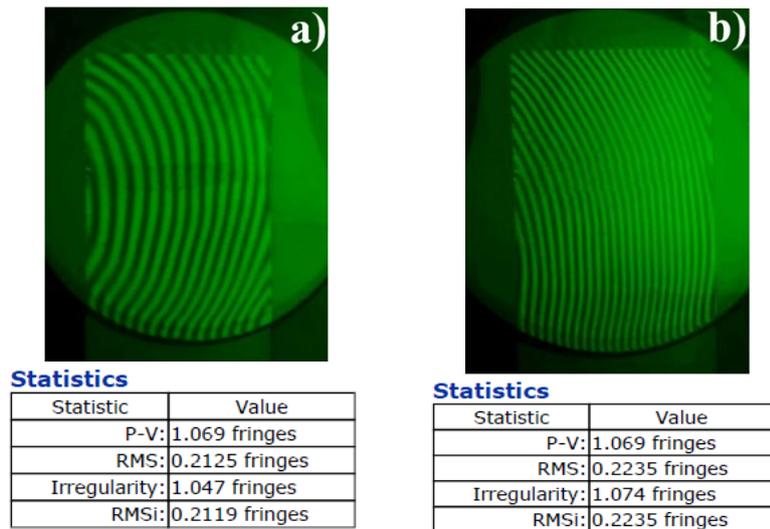
The interferogram that is shown in figure 7a was taken before polishing the area 2 of surface 2. In this figure it can be seen a horizontal gray shadow in the fringe pattern. This shadow corresponds to one of the stains on the surface. The values obtained from the analysis of this interferogram were 1.069 frg PV and 0.2125 frg *rms*.

Figure 7. Data and interferogram a) before and b) after polishing surface 2.

The hand polishing time consuming for surface 2 to get stains vanishing was 5 minutes, the same of the last test. Comparing these results against the results for surface 1, this test the scratch and dig defects did not appear because the caustic soda is not more aggressive than the aqua regia. After the hand polishing, the values obtained for the interferogram shown in figure 7b were 1.069 frg PV and 0.2235 *rms*. In this test, the variation in PV and *rms* was 0% and 5%, respectively. Also, it can be seen in figure 7b that the shadow of figure 7a disappeared completely without affecting the irregularity of the interference pattern.
